BALLISTIC RESEARCH LABS ABERDEEN PROVING GROUND MD  
HIGHLY SURVIVABLE TRUSS TYPE TAIL BOOM, (U)  
JUN 78 T F ERLINE

12-15 P.  
② HIGHLY SURVIVABLE TRUSS TYPE TAIL BOOM,  
⑪ JUN 1978

⑩ THOMAS F. ERLINE MR.  
BALLISTIC RESEARCH LABORATORY  
ABERDEEN PROVING GROUND, MARYLAND 21005

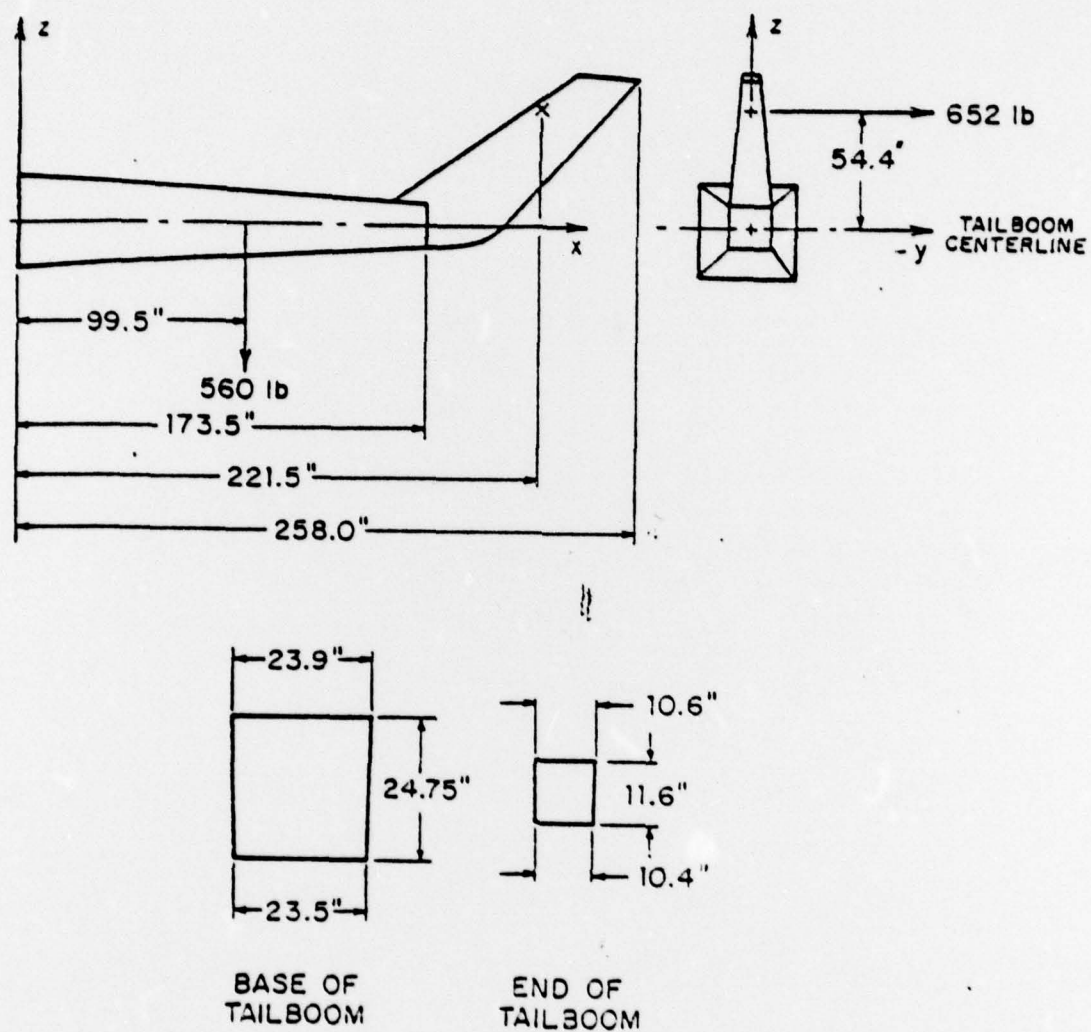
Figure 1. Geometry of Helicopter Tail Boom.

PROCEDURES. The longerons are the longitudinal elements which constitute the basic configuration to be employed in the truss structure model development. The basic overall dimensions come from the AH-1G helicopter reported in reference (2) (see Figure 1). Longer-on pattern at the larger (or base) end has been selected to conform to the bolt pattern of the AH-1G model at the tail boom - main fuselage manufacturing break line. The aerodynamic loading conditions were obtained from Bell Helicopter Company.(3) Common design parameters and formulas are listed in Table 1. Consideration of cost and logistics leads the ideal design concept to have all structural truss members with the same cross sectional dimensions. There is less cost involved buying large quantities of structural elements all the same size than small quantities of various sizes. The standard tube(4) structural element of 3.81cm (1 1/2 in) outside diameter and .159cm (1/16 in) thickness was chosen for this study because of its higher inertia over rods of the same cross sectional area.

Initial model goal was a high degree redundancy. The goal was achieved by orienting outside diagonals at 45° angles, which generated a large number of joints (44) within the dimensional bounds of Figure 1. Though truly highly redundant and damage tolerant, the geometric configuration is not a low weight design. To obtain a geometric configuration conducive to a low weight design without doing a geometry optimization analysis, this study utilizes only the joint locations described in reference (7). Thus, both models of this

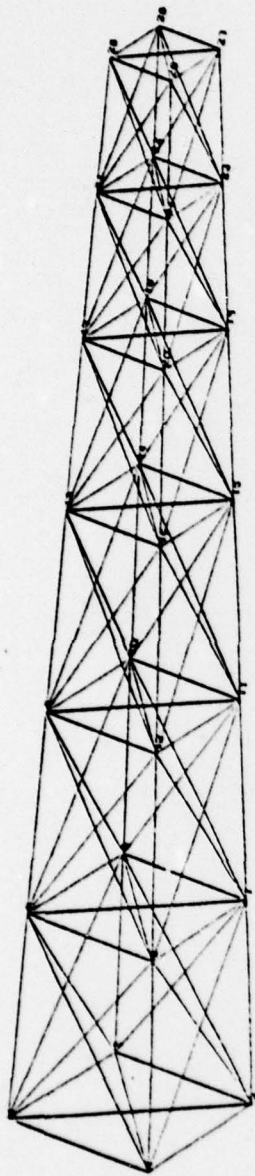
Figure 2. Computer Drawing  
of Model 1.

study have 28 joints and 72 degrees of freedom. Model 1 is an open truss framework containing 114 members (see Figure 2). Model 2 is a substructured truss framework by the inclusion of the interior diagonals generating a total of 138 members (see Figure 3). The chosen standard structural tube element makes Model 1 weigh approximately 40.8 kg (90 lbs), and Model 2 weigh approximately 52.2 kg (115 lbs).

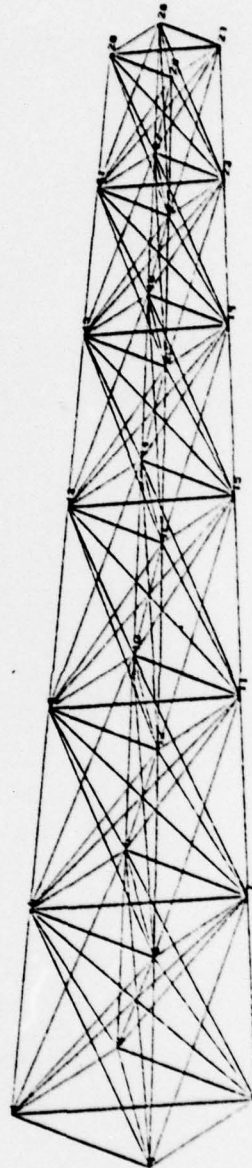
Figure 3. Computer Drawing  
of Model 2.
